# Estonian Road Traffic Safety Audit Project

## Highway 3 Jõhvi-Tartu-Rõngu

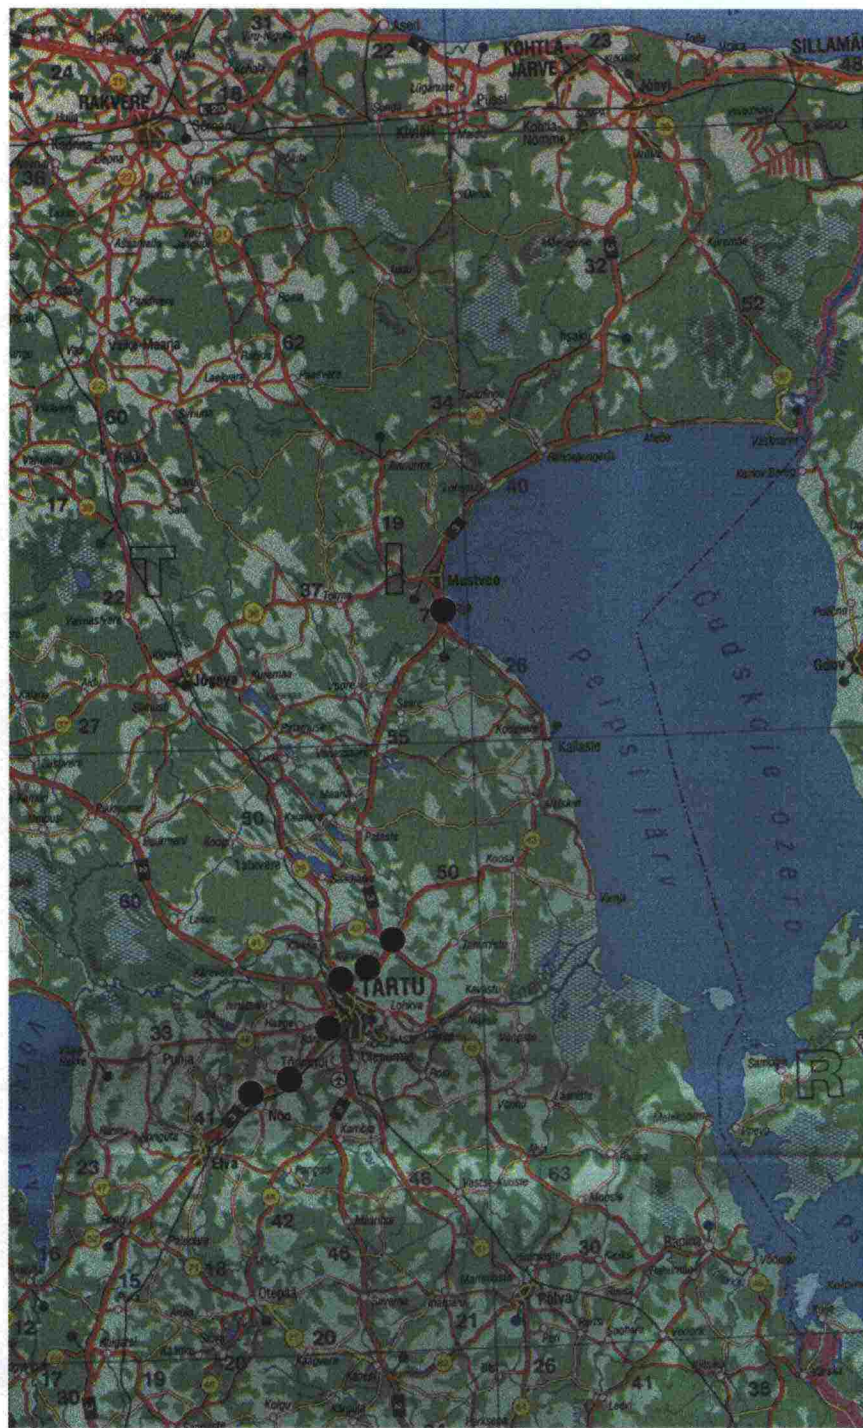
Picture 4.3. Black spots of A8.

Km at beg.	Km at end	Number of accidents (Killed/Injured)	Location and the main reason for accidents
75	81	11 (4/21)	Raja-Kasepää; running of the road, collision with the pedestrians
122	123	4 (0/7)	Aovere; running of the road
124	127	6 (0/11)	Kõrveküla, side collision (intersection)
127	130	4 (0/4)	Aru, running off the road
138	140	7 (1/9)	Räni, collision with bicycle or pedestrian
142	145	11 (3/10)	Kõlitse, collision with pedestrian
149	153	6 (0/9)	Nõo, head-on collision

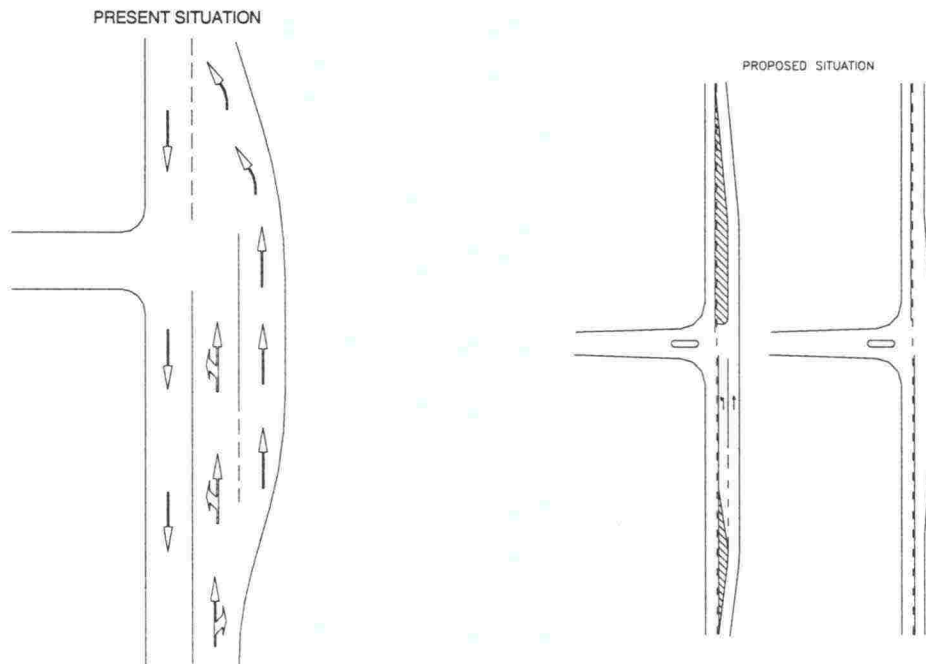
Picture 5.2. Turning lanes, present and proposed situation (either separate turning lane or by-pass zone).

The road markings (arrows), which determine the turning lanes, are not marked according to the European standards. In the same lane, the first arrow may point to right, and the next arrow may point to left (see picture 5.2). Also, nearer the intersection, it is forbidden to change the lane (e.g. from left turning/straight moving lane to right/straight moving lane) according to the road markings. In our opinion, this may cause confusion. These markings were most common in Tartu county on the section with old pavement. AT suggests they should be re-marked gradually with left turning lane marking or by-pass zone according to the picture 5.2.

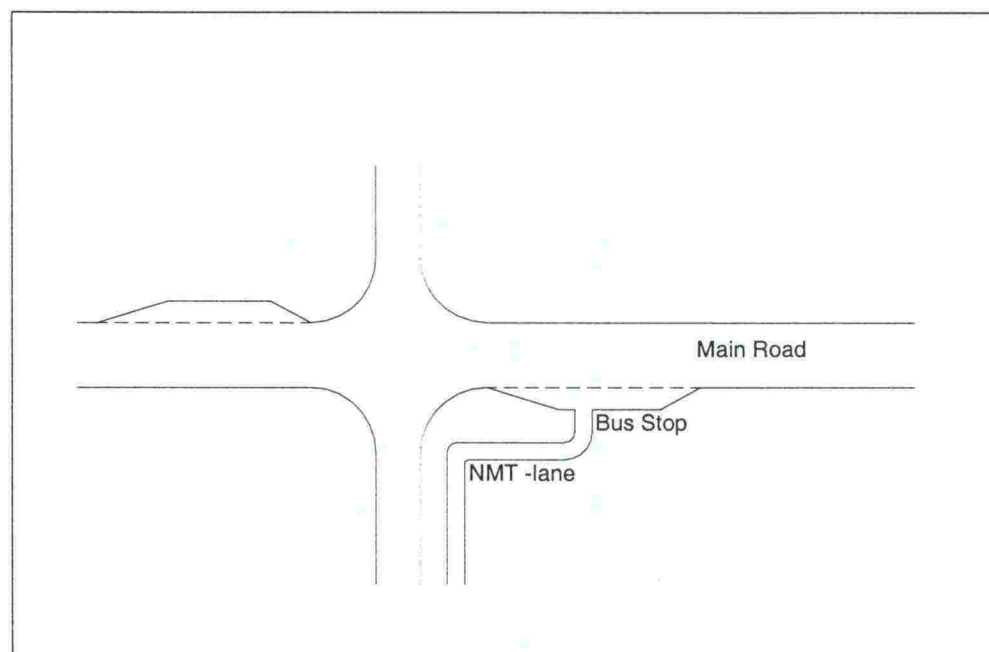
Picture 5.7. Schematic illustrations of the bus stop arrangements in the intersection area.

The bus stops were not always properly situated. They should normally be situated after the intersection. Waiting areas are normally large enough, but in many cases there is a lack of proper routing preventing the pedestrian from safely reaching the bus stop (see picture 5.7).

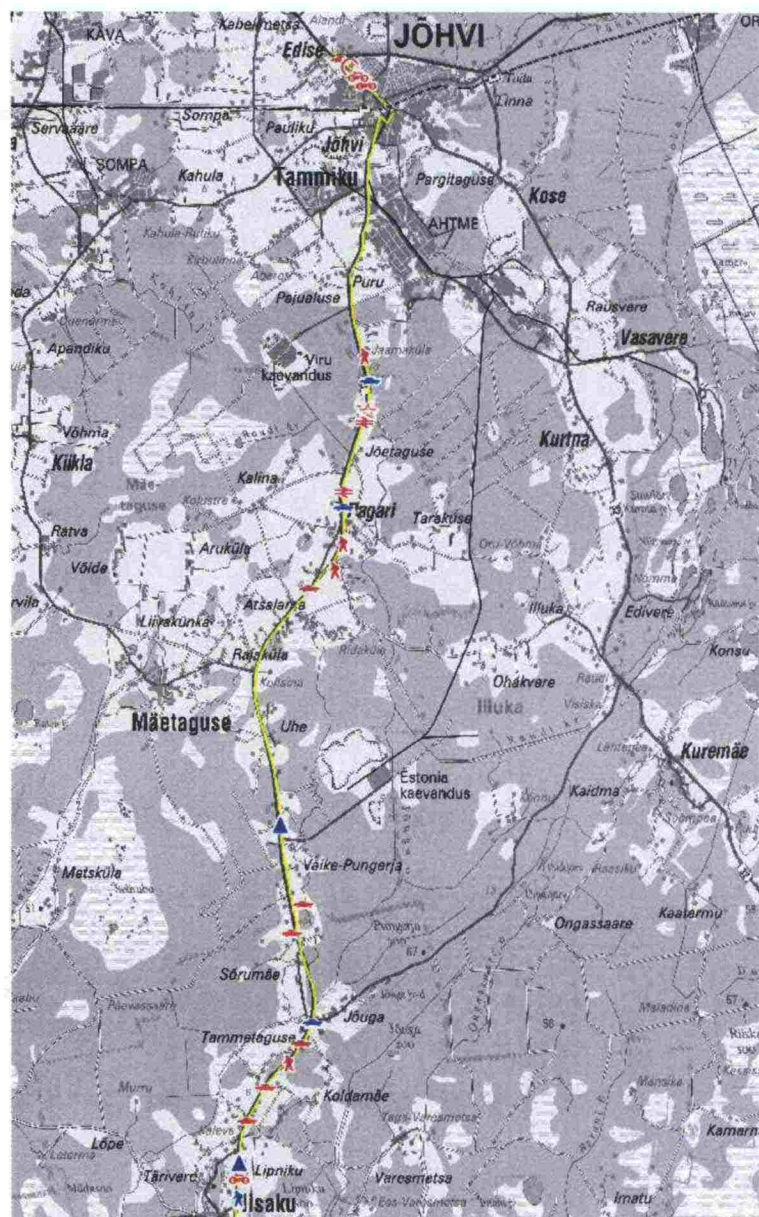
Picture 5.8. Accident locations between Jõhvi and Iisaku.

The traffic volume of this long section is highest near Jõhvi with 2400 vpd. Between Iisaku and Kauksi the traffic volume is lowest along the whole audited section about 900 vpd. The alignment is fairly straight at the beginning part. After Iisaku more curves seem to appear. The curves relate probably on the several overturns on this part.

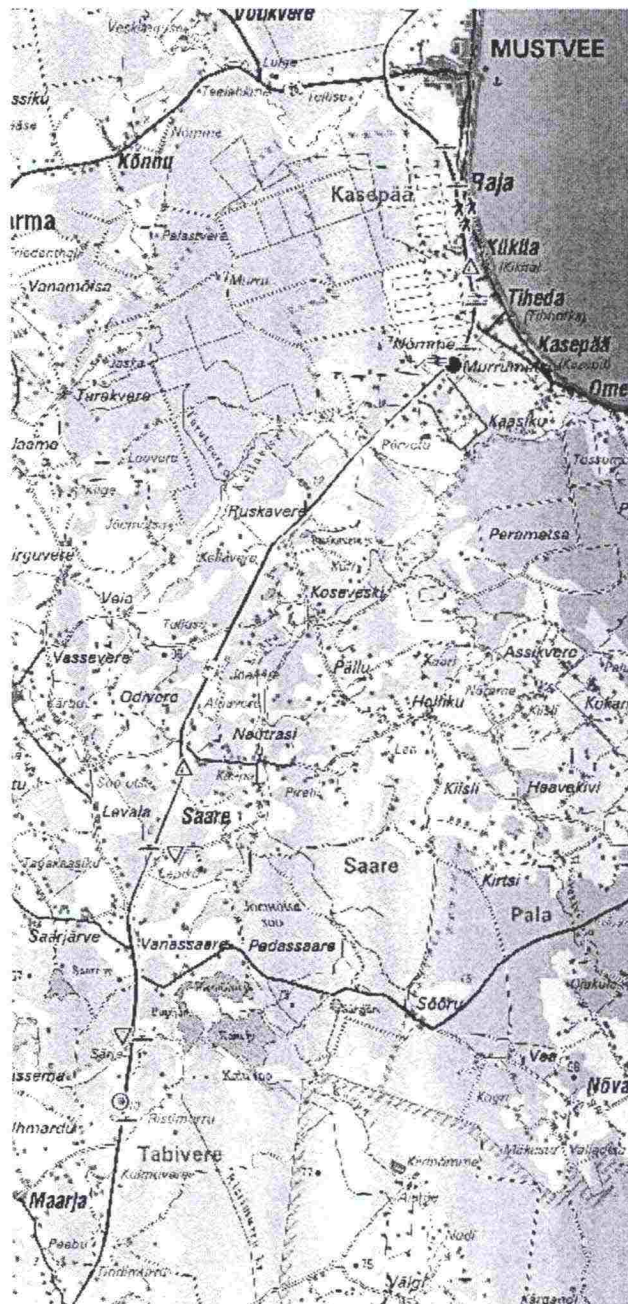
Picture 5.13. Accident locations between Mustvee and Igavere.

Problems of this section focus on the first kilometres of the section between Mustvee and Kasepää. Running off the road and pedestrian accidents are common on this section. The road is straight along this section, which easily persuade the drivers to overspeed. Some of the running offs relate definitely on slippery or foggy road conditions.

Pedestrian accidents relate on the part of village Raja, where local people gather along the road to sell their articles to the passers-by. AT sees the best way to get the situation improved is to build a separate place for all sellers on the eastern side of the road. When constructing the separate sellers'/resting area, old road can be used to this purpose. This idea is presented in the picture 5.14. The realisation of this idea would need the co-operation of the local sellers. After construction of the separate selling/resting area the selling along the road would be prohibited as well as the parking of the vehicles beside the road. The selling area should be dimensioned for both all sellers and parking vehicles.

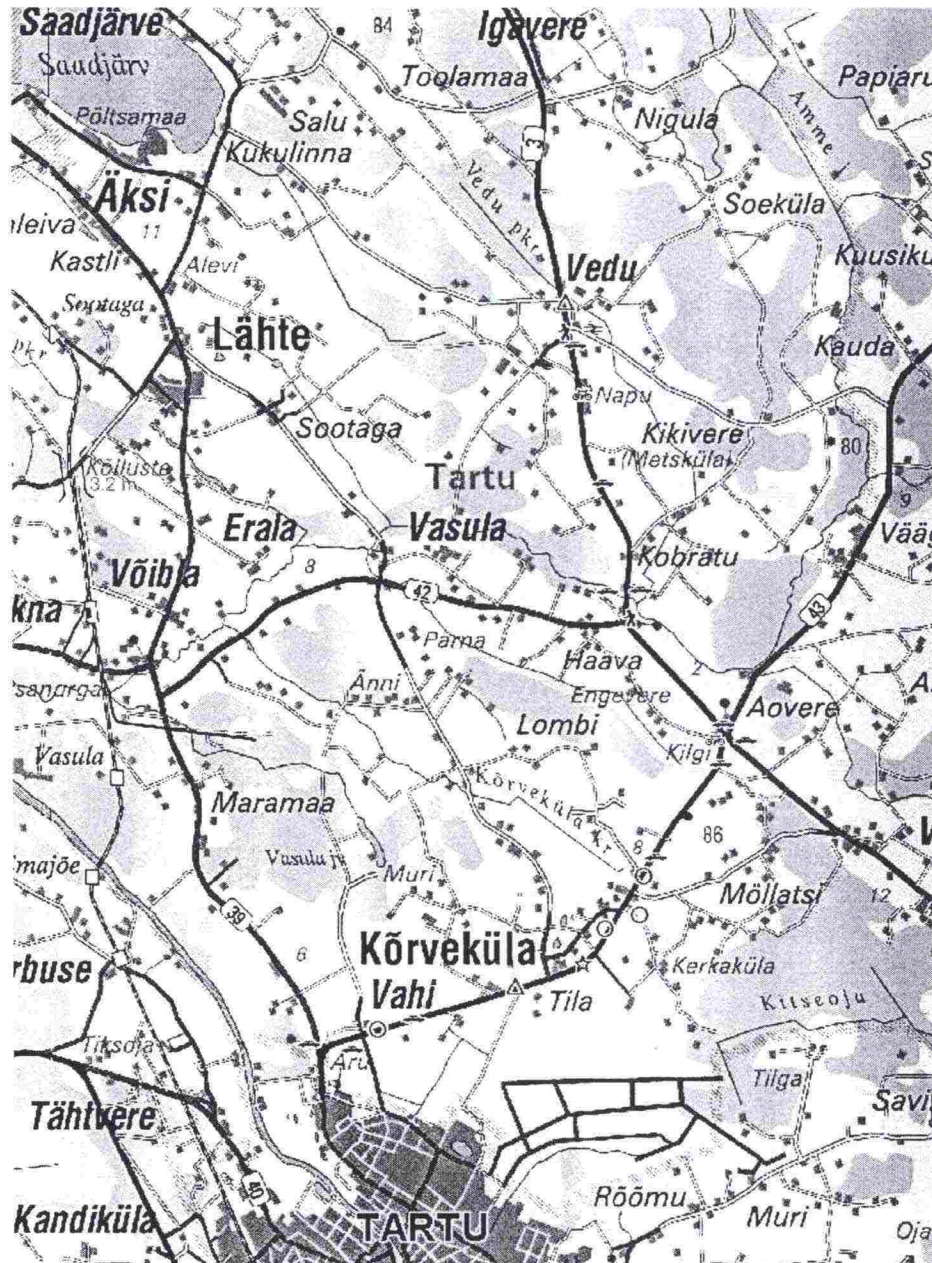
Picture 5.16. Accident locations between Igavere and Tartu.

Accidents exist quite densely on the section in Tartu county from Vedu to the point, where municipality's responsibility begins. The proper camber as well as sufficient road markings fail from the road. The road itself has a wide cross-section, although the shoulders are from gravel.

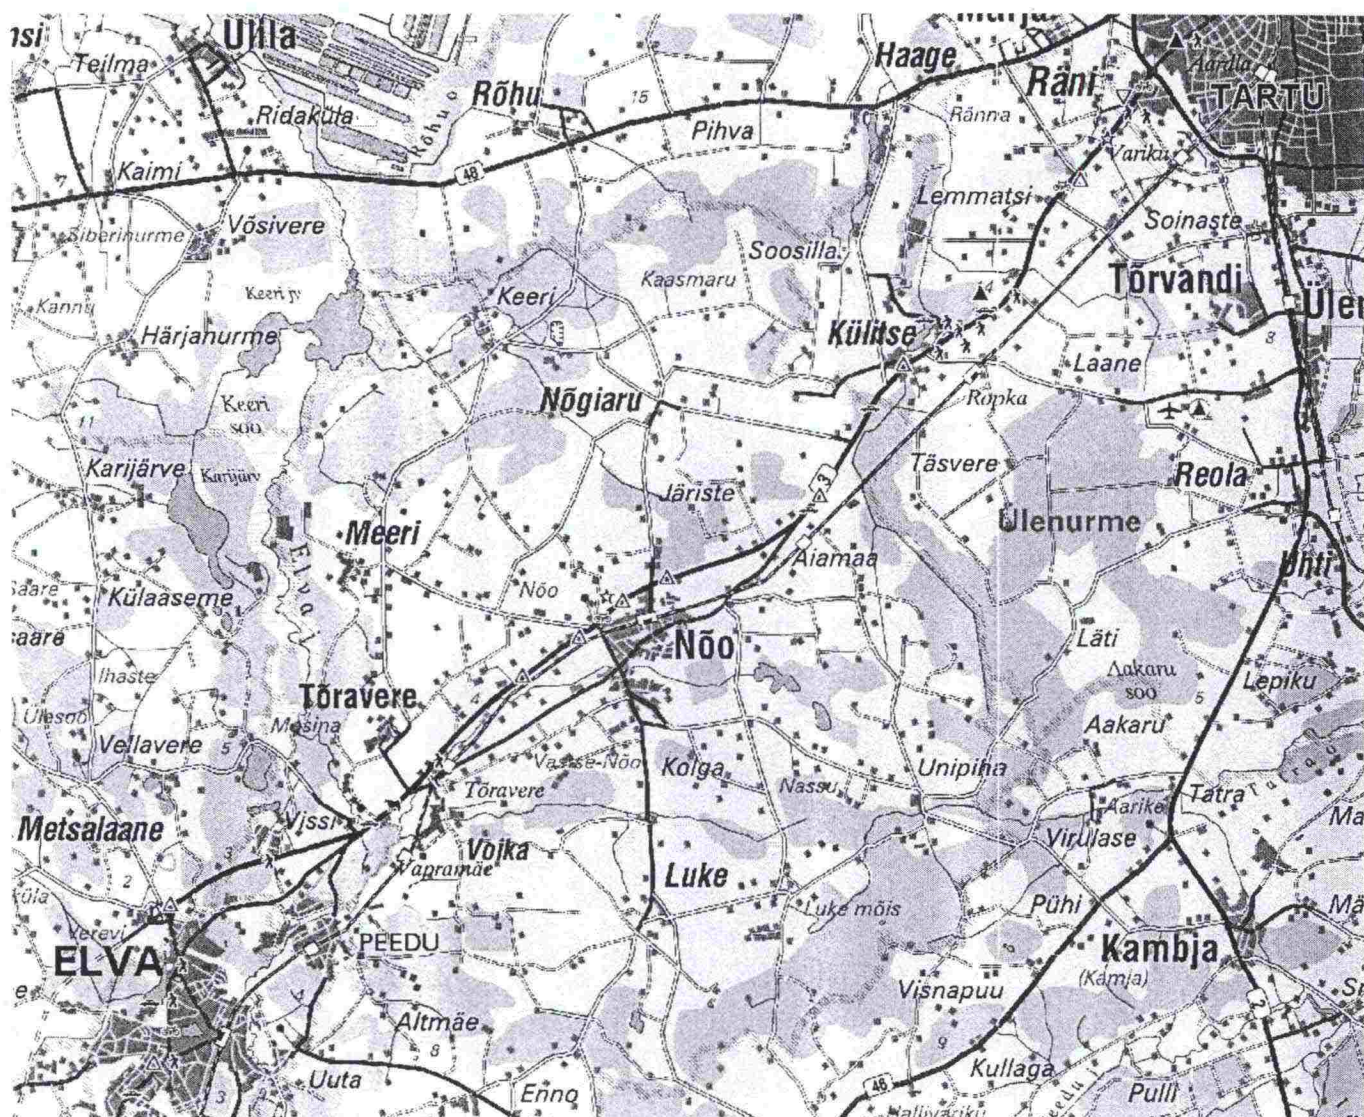
Picture 5.18. Accident locations between Tartu and Elva.

The section after Tartu towards Elva is the section that needs perhaps most urgent some actions. The most dangerous short spots along the road are situated along this section. The problems situate especially in three different points; Rāni, Kūlitse and Nõo. As a first aid to prevent more accidents to happen, all three spots would need lower speed limit. Setting the speed limit lower wouldn't radically change the behaviour of the road user, but with this action more time could be obtained for solving the problems. All the three points near urban settlements need also reorganisations of junctions and accesses.

AT sees at least in Rāni and Kūlitse the most serious problem is the one related to the pedestrian and bicycle traffic.

In a long run a separate pedestrian way all the way to the Nõo would be needed, when improving the status of non-motorised road users. Some accidents are related to the bus traffic., when the NMT has overcrossed the carriageway. The best way to get rid of such accidents is to construct an underpassage for the NMT: AT sees that because of flat landscape the underpassage would not be a perfect solution in Kõltsa. It is too easy to cross the road from the bus stop direct. Therefore proper bus-bays (see picture 5.19) with some transition from the carriageway are needed at least in Kõltsa. The purpose of separate bus-bay outside the road would affect so that the NMT couldn't rush then direct across the road. These bus-bays both sides of the road could be constructed immediately.

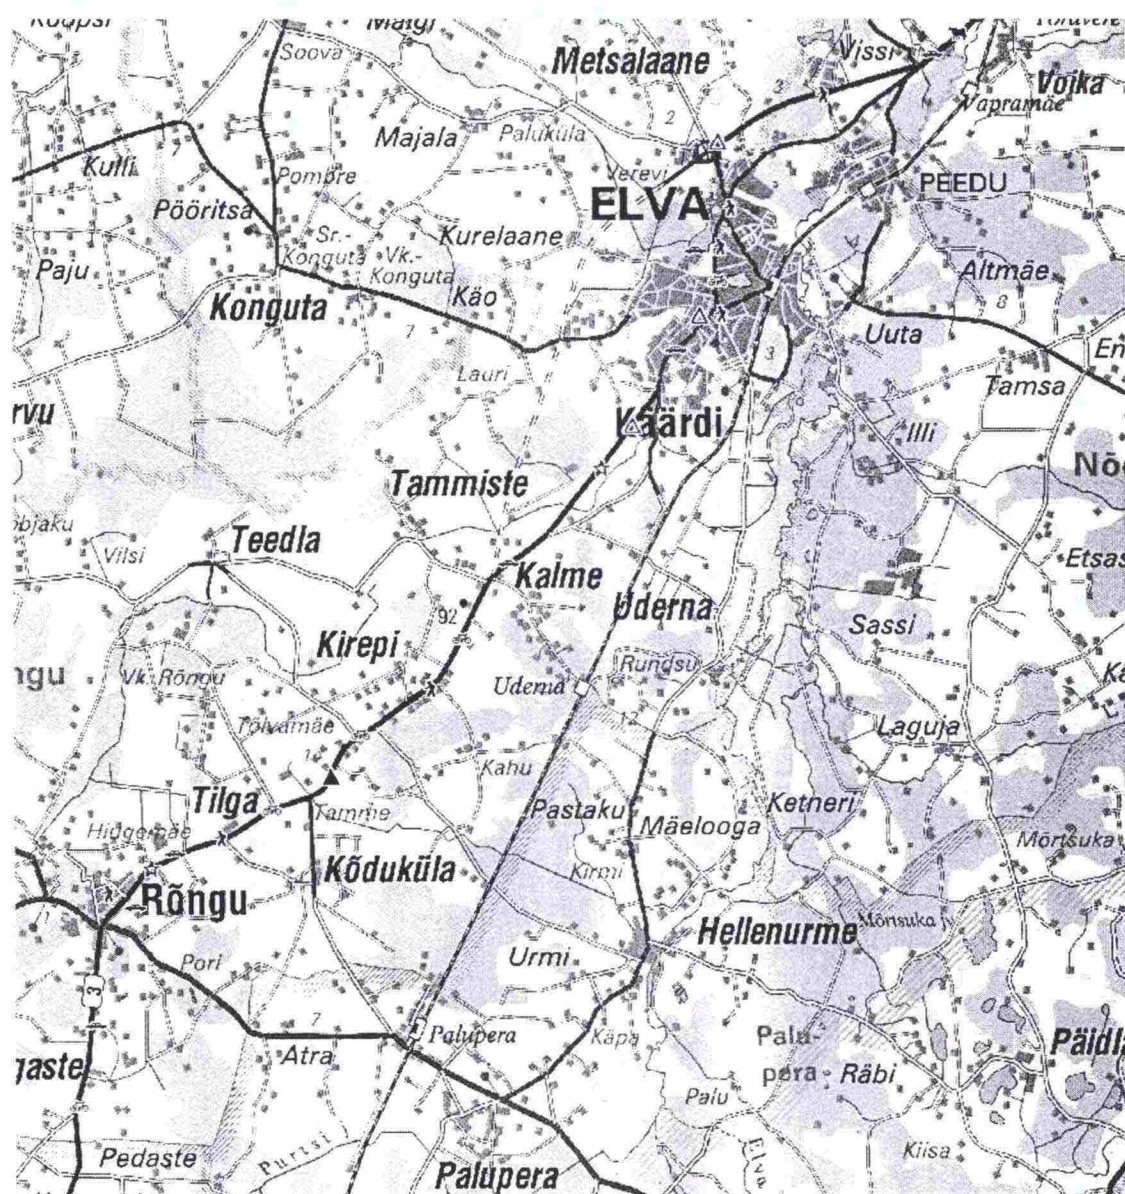
Picture 5.23. Accident locations between Elva and Rõngu.

One of the most hazardous intersections is situated in Kalme in the southern end of the by-pass of Elva. There are too many intersections to the main road at one spot. To make even more confusion a yard access is allowed to a place, where old highway exits towards Elva. Two possible solutions are presented to replace the current situation (see picture 5.24.). Main purpose of the proposed solutions is to minimise the amount of the intersections on the main road.

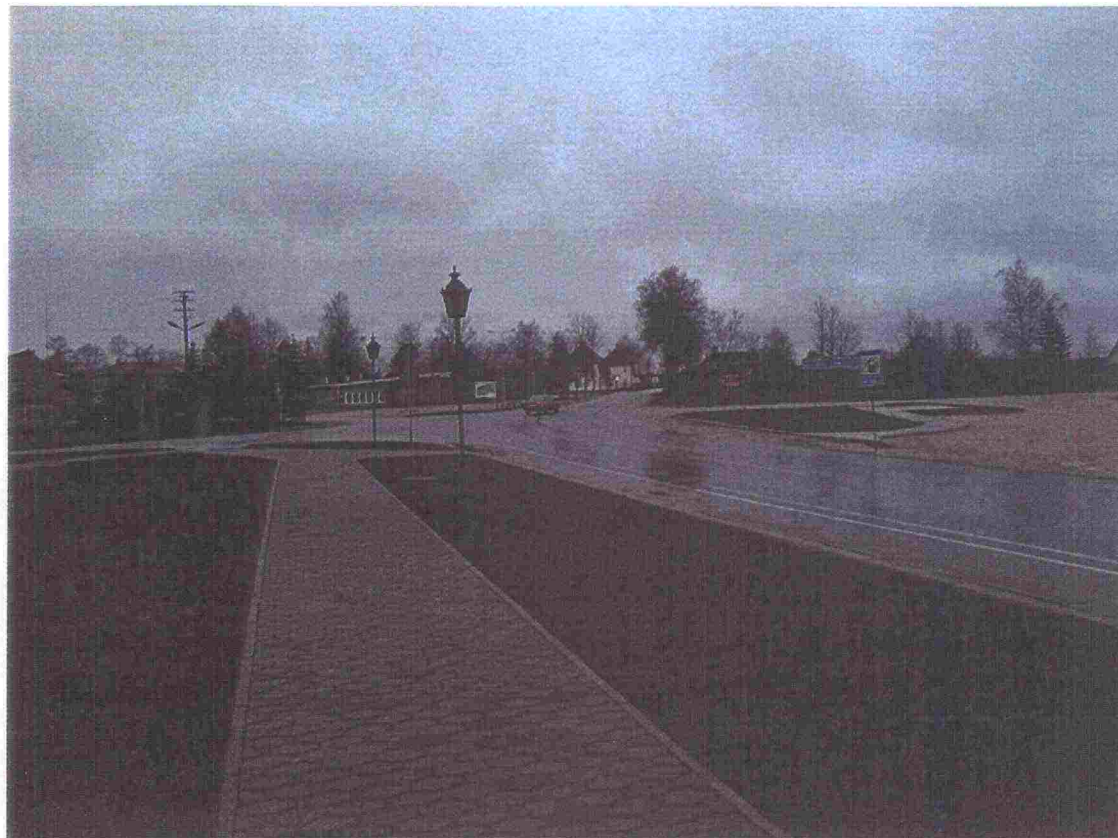
*Picture 5.27. Main intersection in Rõngu*
